**JUNEAU AREA MASS-WASTING &  
SNOW AVALANCHE HAZARD ANALYSIS**

**Prepared For: City & Borough of Juneau, Alaska**

Art Mears  
Arthur I. Mears, P.E., Inc.  
Gunnison, Colorado

February 1992

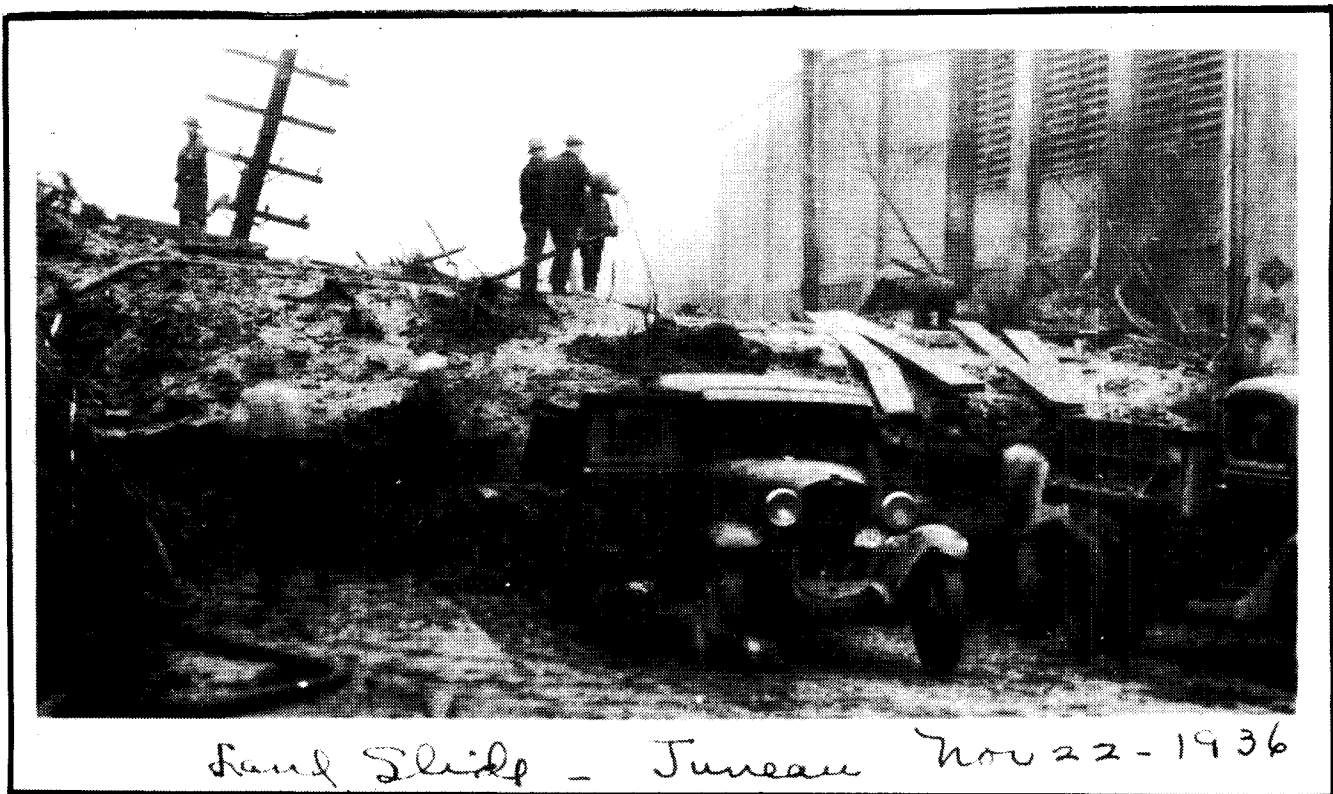
**Figure 2.** Debris avalanches such as this one on S. Franklin St. (Nov. 22, 1936) exert large thrust pressures against fixed objects while moving and significant depositional forces after movement stops. Flows can be several feet thick and carry rocks and large trees. Source: Alaska Historical Library, Early Prints of Alaska Collection.

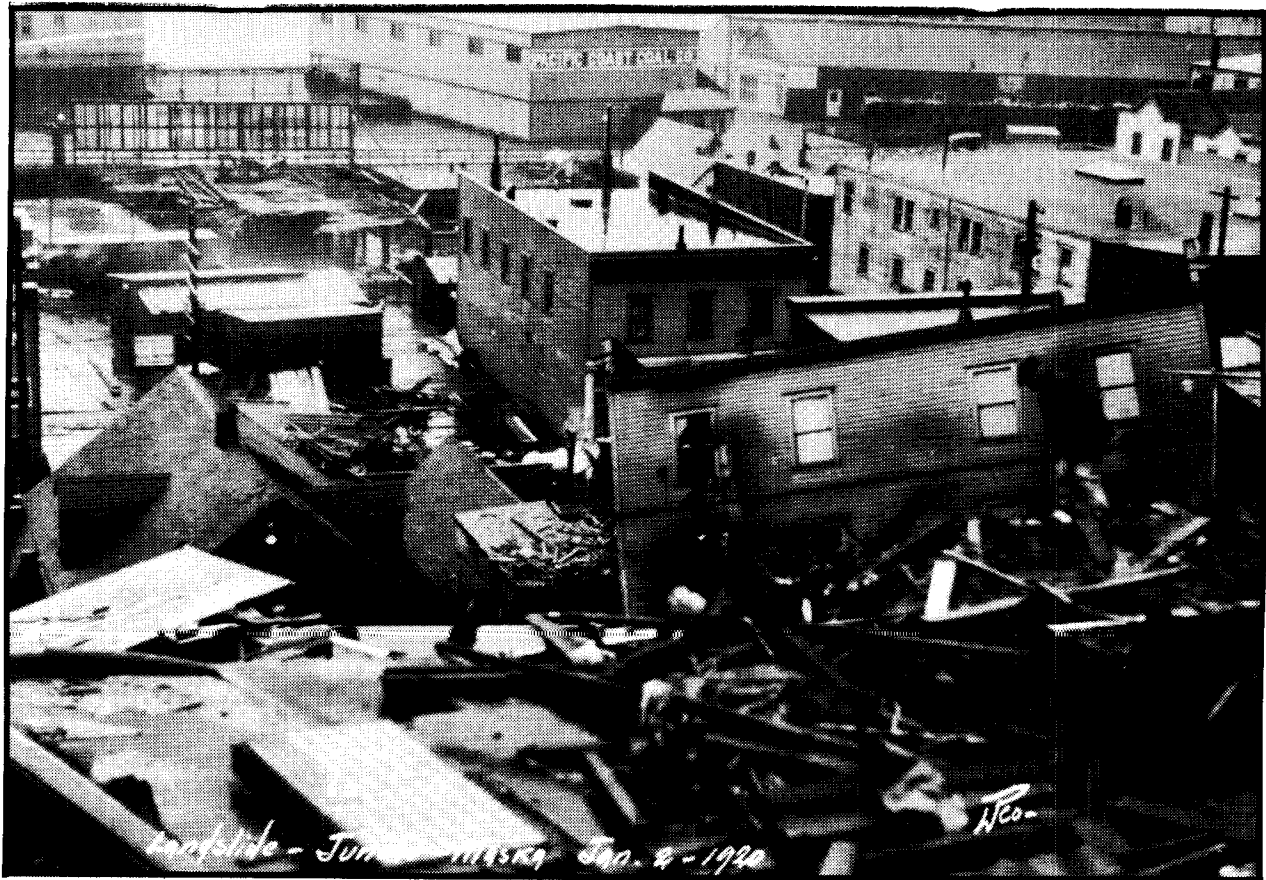
**Figure 3.** This view of the area between Gastineau Ave. and S. Franklin St. (Jan. 2, 1920) illustrates how buildings were destroyed by a debris avalanches through the processes of impact and relocation. Source: Alaska Historical Library, Early Prints of Alaska Collection.

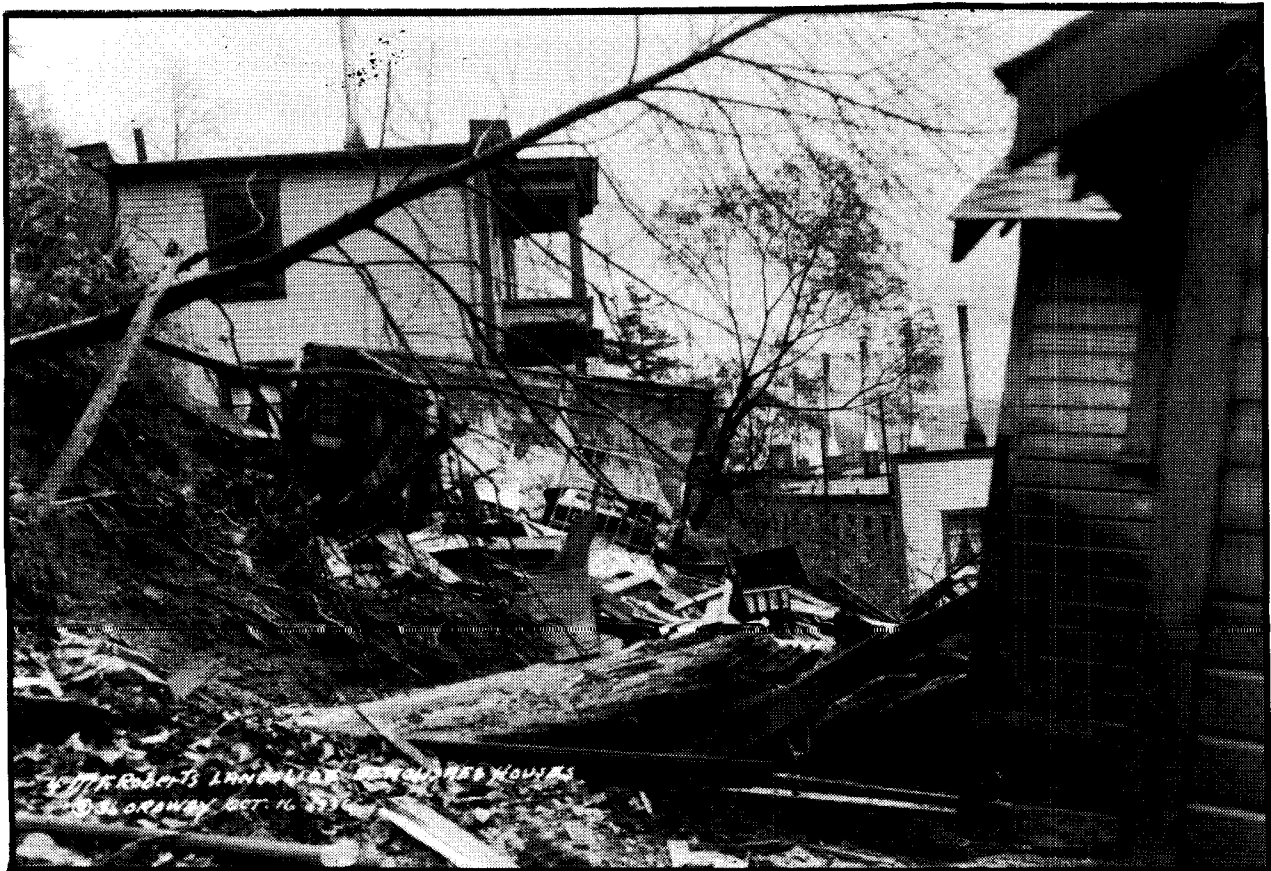
**Figure 4.** This debris avalanche on Oct. 16, 1936 destroyed buildings between Gastineau Ave. and S. Franklin St. by crushing and relocation. Source: Alaska Historical Library, Early Prints of Alaska Collection.

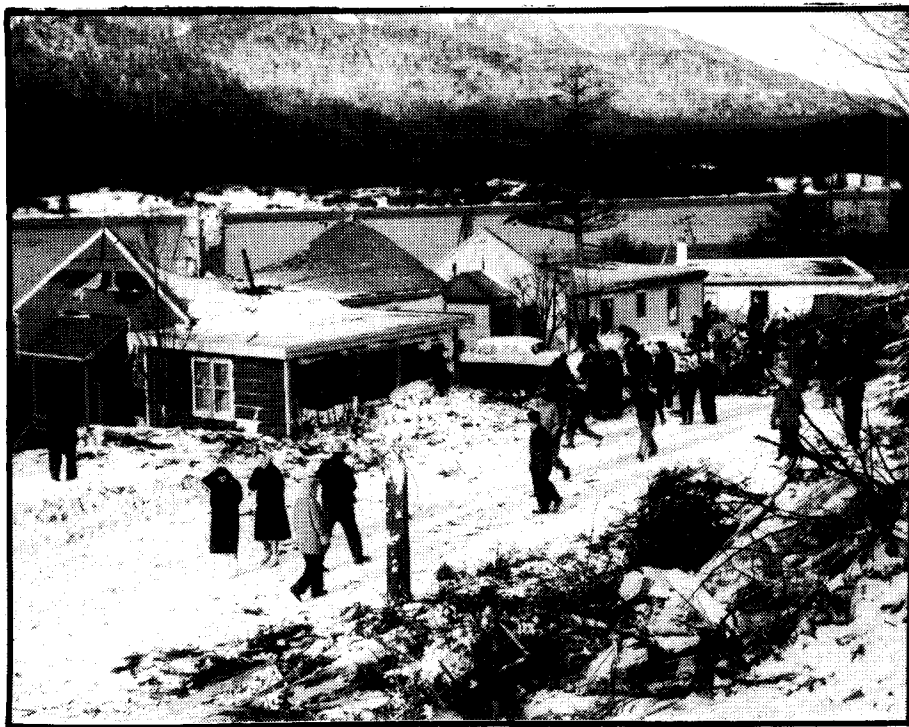
**Figure 5:** Taken shortly after the March 22, 1962 Behrends Ave. avalanche, this photograph illustrates some of the damage resulting from the powderblast of this fast moving low density avalanche. Thirty five houses were damaged: some were pushed off of foundations, roofs were blown off, walls pushed in, chimneys snapped off, trees broken and hurled through walls and roofs, and windows were blown in or sucked out. Photo source: Alaska Mountain Safety Center, Inc., Hart Collection.

7. 1962, 03-22, 0530: The most destructive avalanche in recent years, this event was precipitated by strong NE winds, cold temperatures, and heavy amounts of new snow and wind-loading which resulted in a major soft slab avalanche with considerable powderblast damage, but very little debris. According to Mr. R.E. (Randy) Randall, who was possibly the only eyewitness, "the airborne-powder avalanche travelled completely across Gastineau Channel terminating near the Treadwell Ditch at elevation 750'" (Source: Hart, 1967, *Report of the Preliminary Evaluation of the Behrends Avenue Avalanche Path*, p 15). In all, approximately 35 residential structures on three streets were damaged. These included:

- . At least seven residential structures received *severe damage* (six on Behrends Avenue: No. 229, 232, 233, 237, 241, and 248; and one on Glacier Avenue: No. 1736);

- . Ten residential structures received *moderate damage* (four on Behrends Avenue: No. 221, 224, 225, and 226; and six on Glacier Avenue: No. 1732, 1735, 1740, 1744, 1748, and 1752); and

- . 18 other structures received *minor damage* from powderblast effects (Ross Way: 105; Behrends Ave.: 201, 204, 205, 206, 207, 208, 217, and 220; and Glacier Ave.: 1700, 1702, 1708, 1712, 1716, 1718, 1720, 1728, and 1754).

- . In addition, considerable personal property was damaged or lost and numerous vehicles, utility poles, power and telephone lines, fences, and trees (approximately 10 acres) were destroyed or damaged. Roofs were blown off, walls pushed in, houses pushed off foundations, chimneys snapped off, trees hurled through walls and roofs, and windows blown in or sucked out.

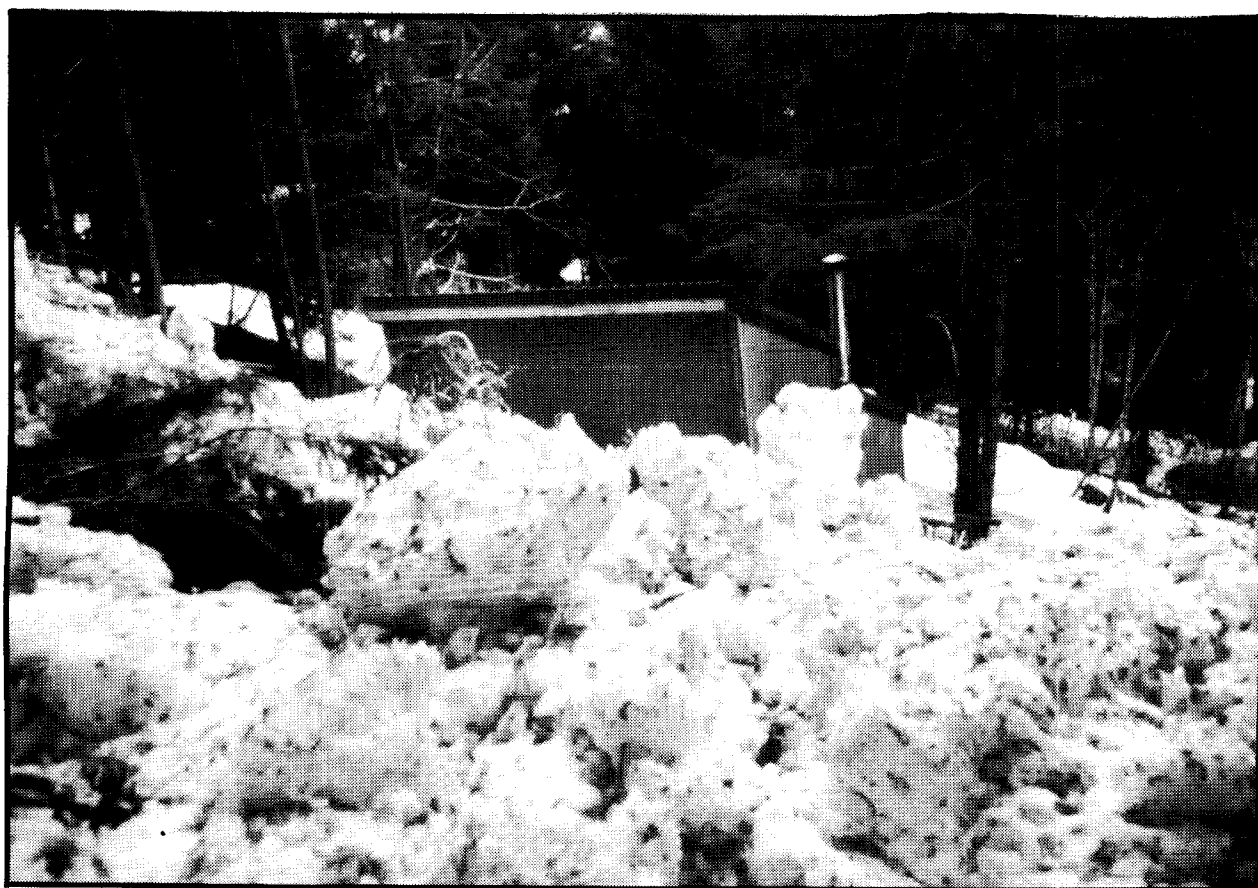
**Figure 6:** The avalanche which hit and damaged this occupied residence in White Subdivision was the 4th slide of the season in this path and the second one in a month to hit the house. Only the second story is visible above the debris and the garage (immediately to the right of the house) is still buried along with the owner's vehicle which was parked in the driveway. Damage from wet snow avalanches such as this usually results from crushing and dislocation. Photo by Doug Fesler, Feb. 20, 1985.

8. 1985, 02-20, 2150: A large avalanche hit and damaged one residential structure (the Tow residence) and partly buried one vehicle and a cache of building materials, came within 10' of a second house (Kohler residence), stopped approximately 70' above a third structure (on Wickersham Ave.), and 150' above a fourth structure (the grey condominium

9. 1985, 03-18, 0530: A large avalanche hit and damaged one residential structure (Tow residence), came within 6' of a second structure (Kohler's), and stopped approximately 60' short of two others below Wickersham Avenue. This is the 4th slide this season in this path and the second slide in a month to hit the Tow residence. Although the debris coverage was extensive (6'-10' from side to side on top of previous debris), this slide was small compared to the potential of the path. The fracture line extended across only the eastern 1/3 of the upper bowl, and then, only to a depth of approximately 3'. As it descended into the rain-saturated snowpack at the lower elevation, it moved along a well-lubricated track, entraining most of the available surface layers of snow. Photos taken. (Sources: Personal communication with Mrs. M. Kohler, Gunnar Noreen, Bruce Bowler, and Chuck Kleeteshulte, Juneau Empire.)
